FACILITY COMPLIANCE INSPECTION REPORT

Division of Waste Management Solid Waste Section

Date of Site Inspection: 4/16/12

Burke County Land Fill – Johns River Facility
 2500 Marsh Trail Rd.
 Morganton, NC 28680

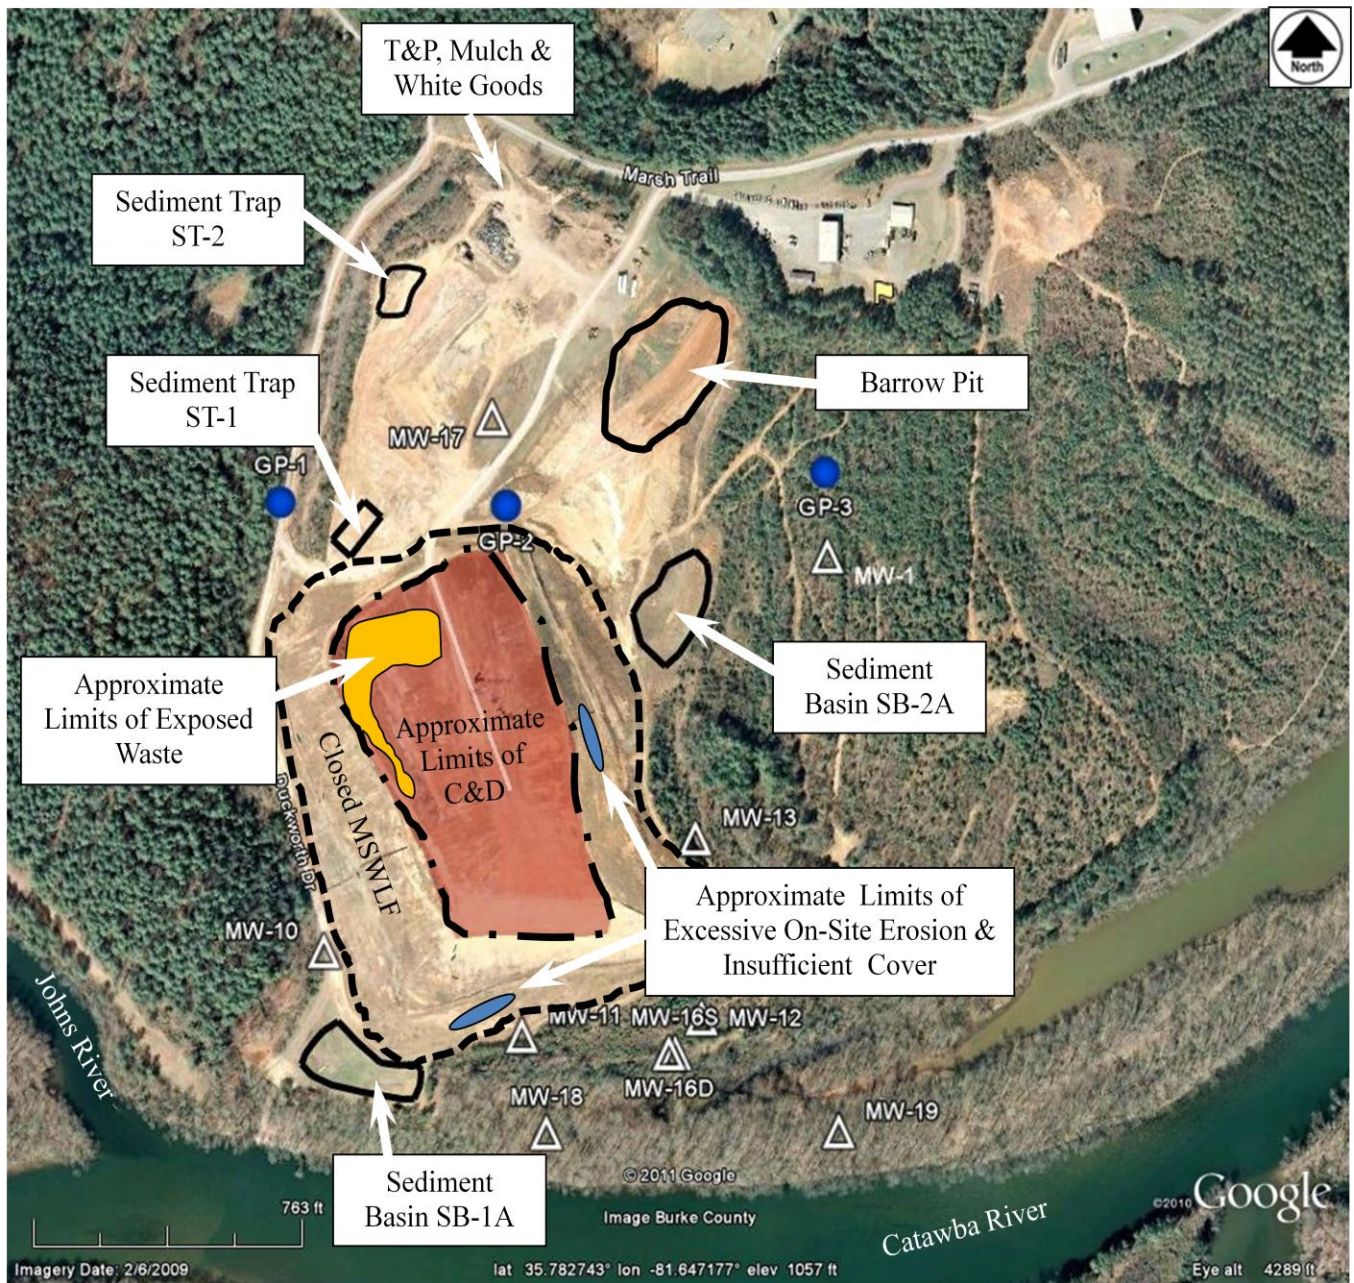
Figure 1: Burke County Active C&D Landfill over Closed MSW Landfill Site Map
(GP – Landfill Gas Monitoring Well MW – Groundwater Monitoring Well)

3. This facility is an unlined C&D landfill over a closed unlined MSW landfill. (Figure #1)
4. Both the C&DLF and the MSWLF are under the same permit (12-03).

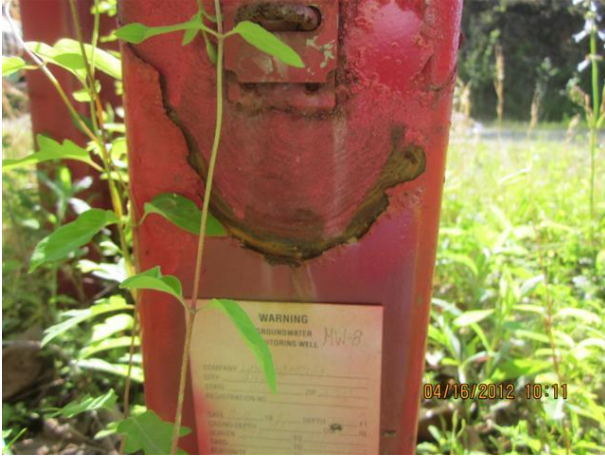
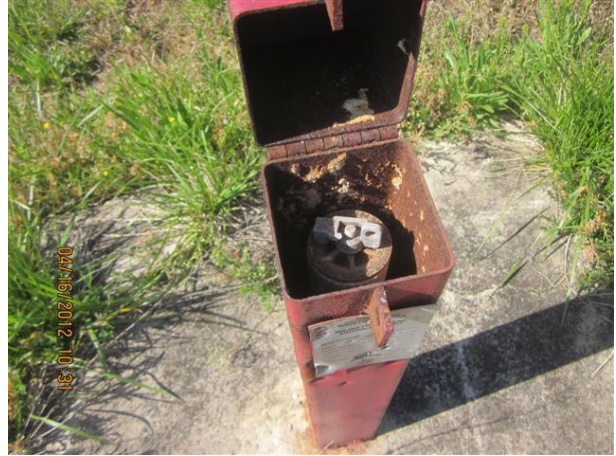
On April 16, 2012 I observed that two of the groundwater monitoring wells were not constructed in accordance with the requirements set forth in 15A NCAC 02C (Photos #1 and #2), as required by 15A NCAC 13B .0544(b)(2). Specifically 15A NCAC 02C .0108(k) requires that: “All non-water supply wells, including temporary wells, shall be secured with a locking well cap to ensure against unauthorized access and use.”

1. Groundwater monitoring well without a pad lock.
(Believed to be MW-8)

2. Groundwater monitoring well without a pad lock.
(Believed to be MW-15S)

In order to correct the above cited violation #4, by May 4, 2012 Burke County must ensure that all groundwater and landfill gas monitoring wells are properly secured to prevent unauthorized access and use in accordance with the requirements in 15A NCAC 02C .0108(k).

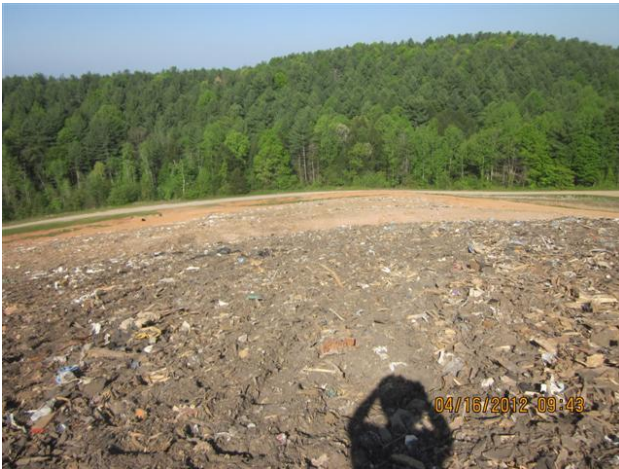
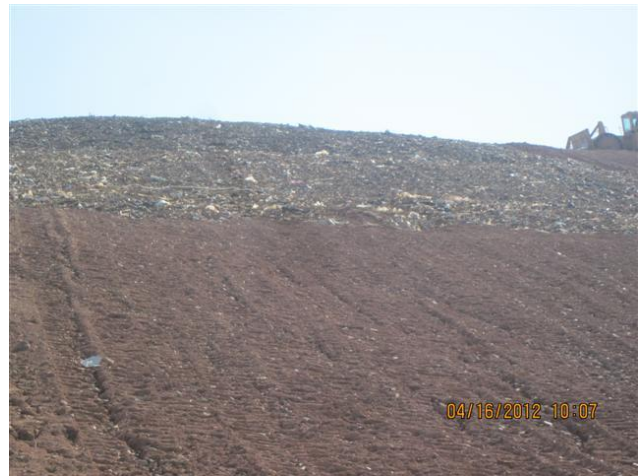
On April 16, 2012 I observed that more than approximately 0.7-acres had not been covered with six-inches (Photos #3 & #4 and Figure 1) of earthen material as required by 15A NCAC 13B .0542(a). Burke County has failed to operate the C&D landfill in accordance with their approved “Operations Plan” in that they have failed to cover waste with six-inches of earthen material when the waste disposal area exceeds one-half acre.

3. Looking NW from the working face at large area of uncovered waste.

4. Looking E, up towards the uncovered waste on the upper western slopes. (Note: compactor at the upper right.)

15. The edge of waste for the C&D landfill has been staked out with permanent markers.
16. The working face of the C&D landfill is located on the north end of the landfill. An excessively large area of exposed waste extends north and west from the working face. (Photos #3 and #4 and Figure 1)

In order to correct the above cited violation #2, by May 4, 2012 Burke County must covering all wastes with six inches of earthen material when the waste disposal area exceeds on-half acre and at least once a week.”

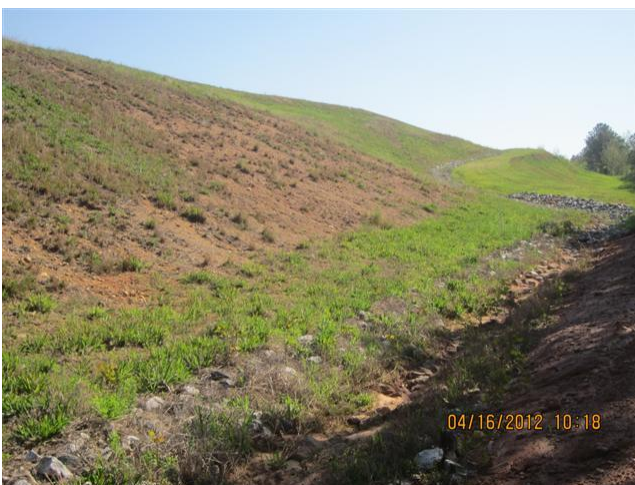
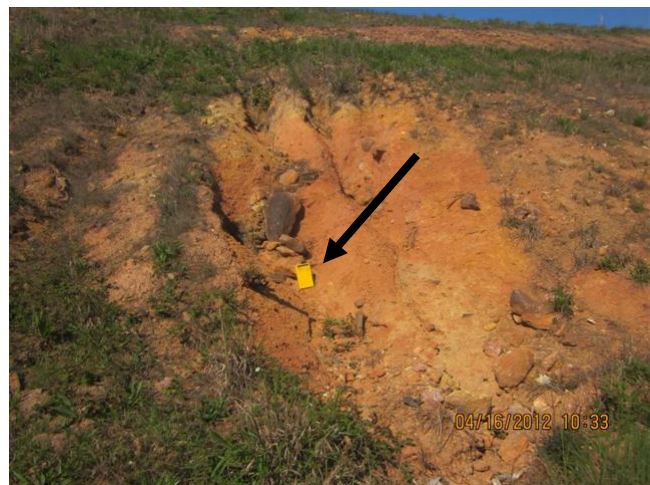
On April 16, 2012 I observed areas of the closed MSW landfill that had excessive on-site erosion in two locations and that these two areas did not have vegetative cover (Photos #5 & #6 and Figure 1).

Burke County has failed to maintain the integrity and effectiveness of the cap system of the MSW landfill in accordance with the requirements in 15A NCAC 13B .1627(d)(1)(A) in that they have failed to make necessary repairs to the cap to correct the effects of erosion, settlement, subsidence and other events from eroding or otherwise damaging the cap system.

5. Excessive on-site erosion & insufficient vegetative cover at the base of the eastern slopes of the closed MSW landfill.

6. Excessive on-site erosion & insufficient vegetative cover at the base of the southern slopes of the closed MSW landfill. (Yellow field book for scale: 4.5" X 7.5")

In order to correct the above cited violation #4, Burke County must immediately take all necessary actions needed to correct all instances of excessive on-site erosion and re-establish a vegetative cover wherever needed, in accordance with the requirements in 15A NCAC 13B .1627(d)(1)(A) and in accordance with their approve Operations Plan.

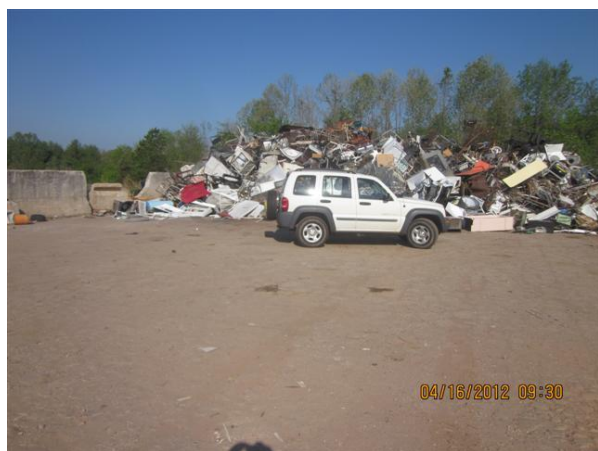
29. White goods are stored on a concrete pad north of the landfill that is surrounded by “jersey” barriers on three sides. (Photo #7)
30. There was a fair amount of white goods on site at the time of the audit.
31. OmniSource Southeast collects the white goods and scrap metal for recycling. OmniSource also removes the CFCs from refrigeration units.
32. No prohibited wastes were observed in the white goods collection area.

7. White goods area.

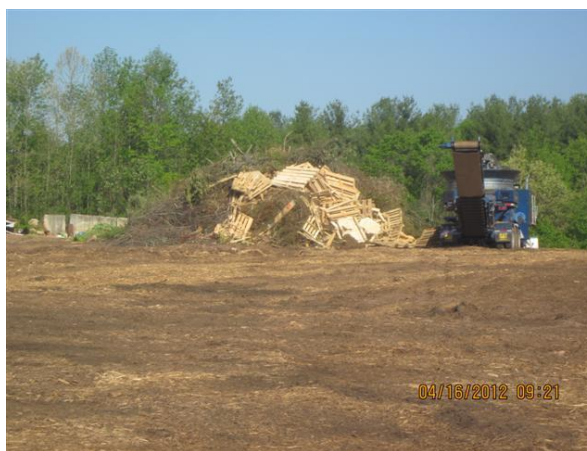
33. Yard waste is ground into mulch for sale to the public: \$9.50 for a small truck load and \$11.00 for a standard truck load; \$38.50 for a “full scoop” - approximately 4 yds.³ (Photos #8)
34. Land clearing debris is ground into mulch for use on-site.
35. Temperature records of the composting process were reviewed. Compost temperatures above 131°F were maintained for three consecutive days as required.

8. Yard waste & untreated wood pile for grinding into mulch.

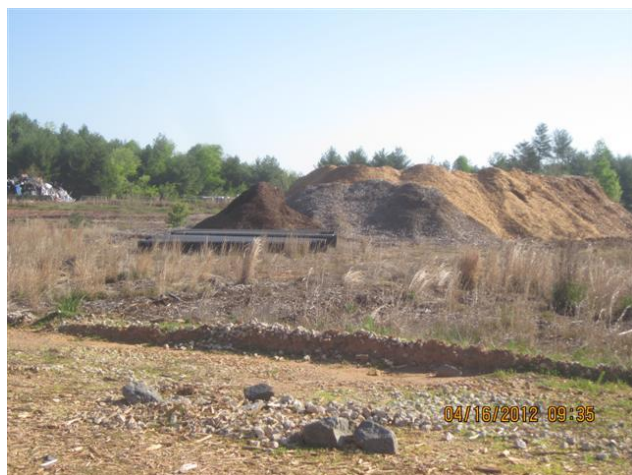
42. There was large amount of ground material from the treatment and processing unit on site. According to landfill staff, the market for boiler fuel is down and the County's existing markets want a product that is not so finely ground. (Photo #9)
43. Please ensure that no more than 6,000-yds.³ of material may be processed or stored on site per three month period, or have on hand at any one time a combination of waste material and finished product that exceeds 6,000-yds.³.

13. Stock pile of boiler fuel.
